Camera - Rear View (Remove and Replace)

Correction Code 17250102

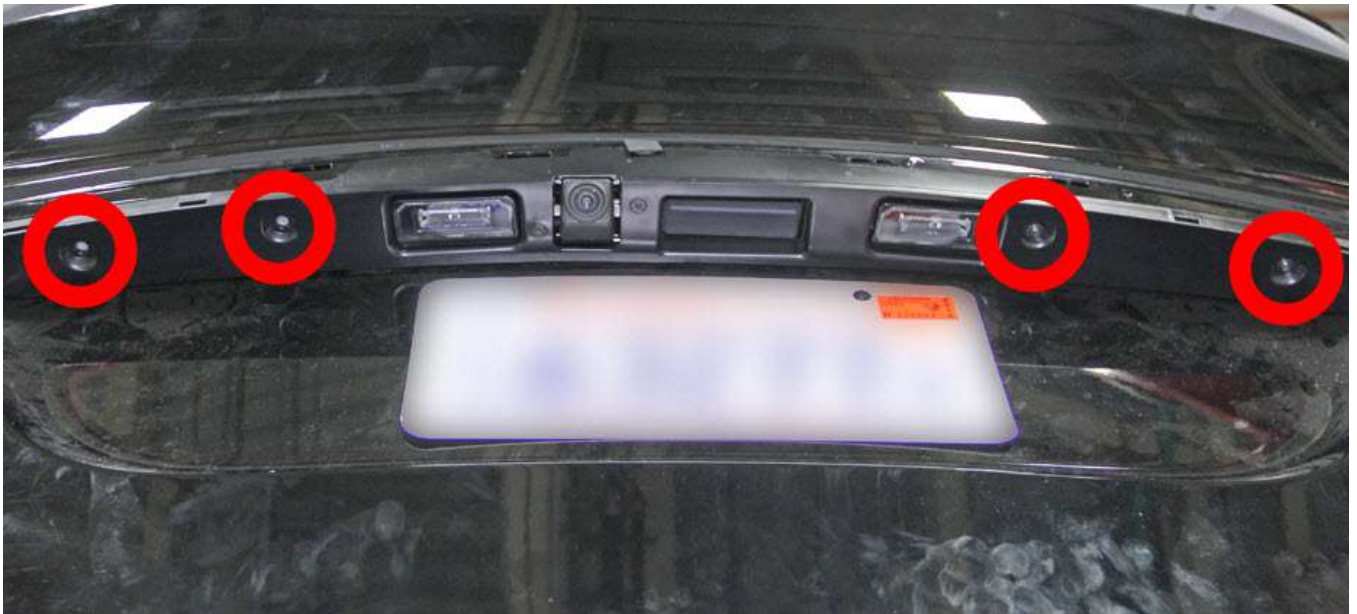
.
3. Remove the screws (x4) that secure the liftgate applique bracket (torque 4 Nm).

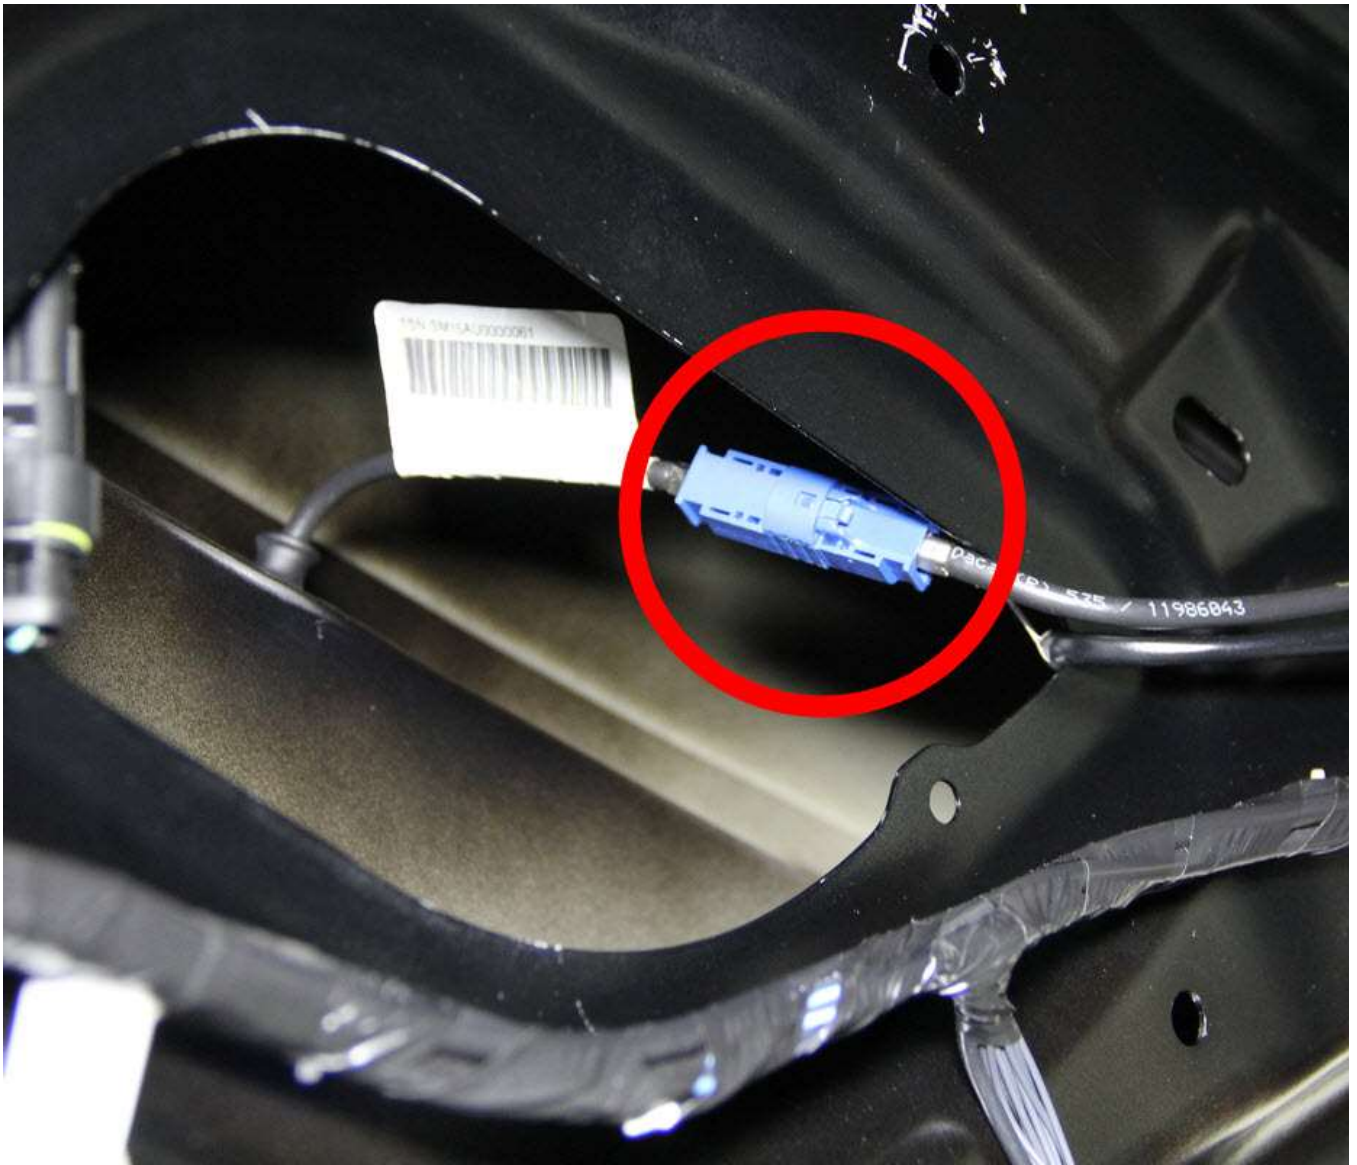
4. Reach inside the LH side of the liftgate and disconnect the backup camera harness.

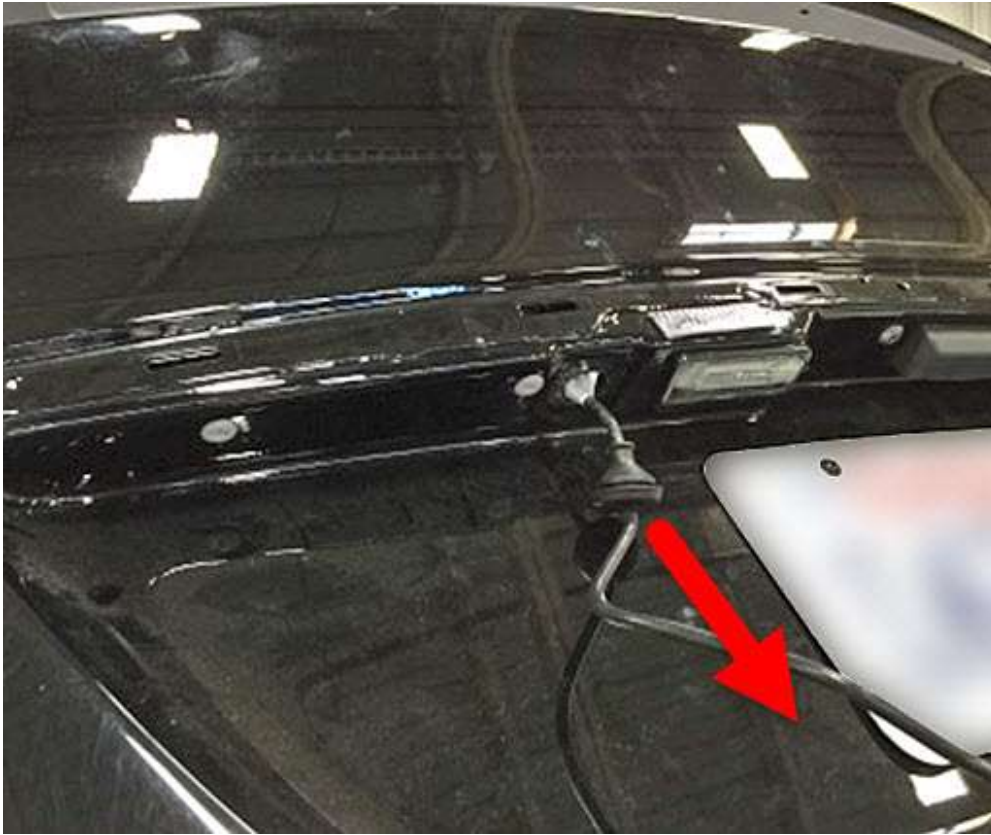
5. Remove the liftgate applique bracket from the vehicle.
6. Pull the camera harness through the opening in the liftgate body.

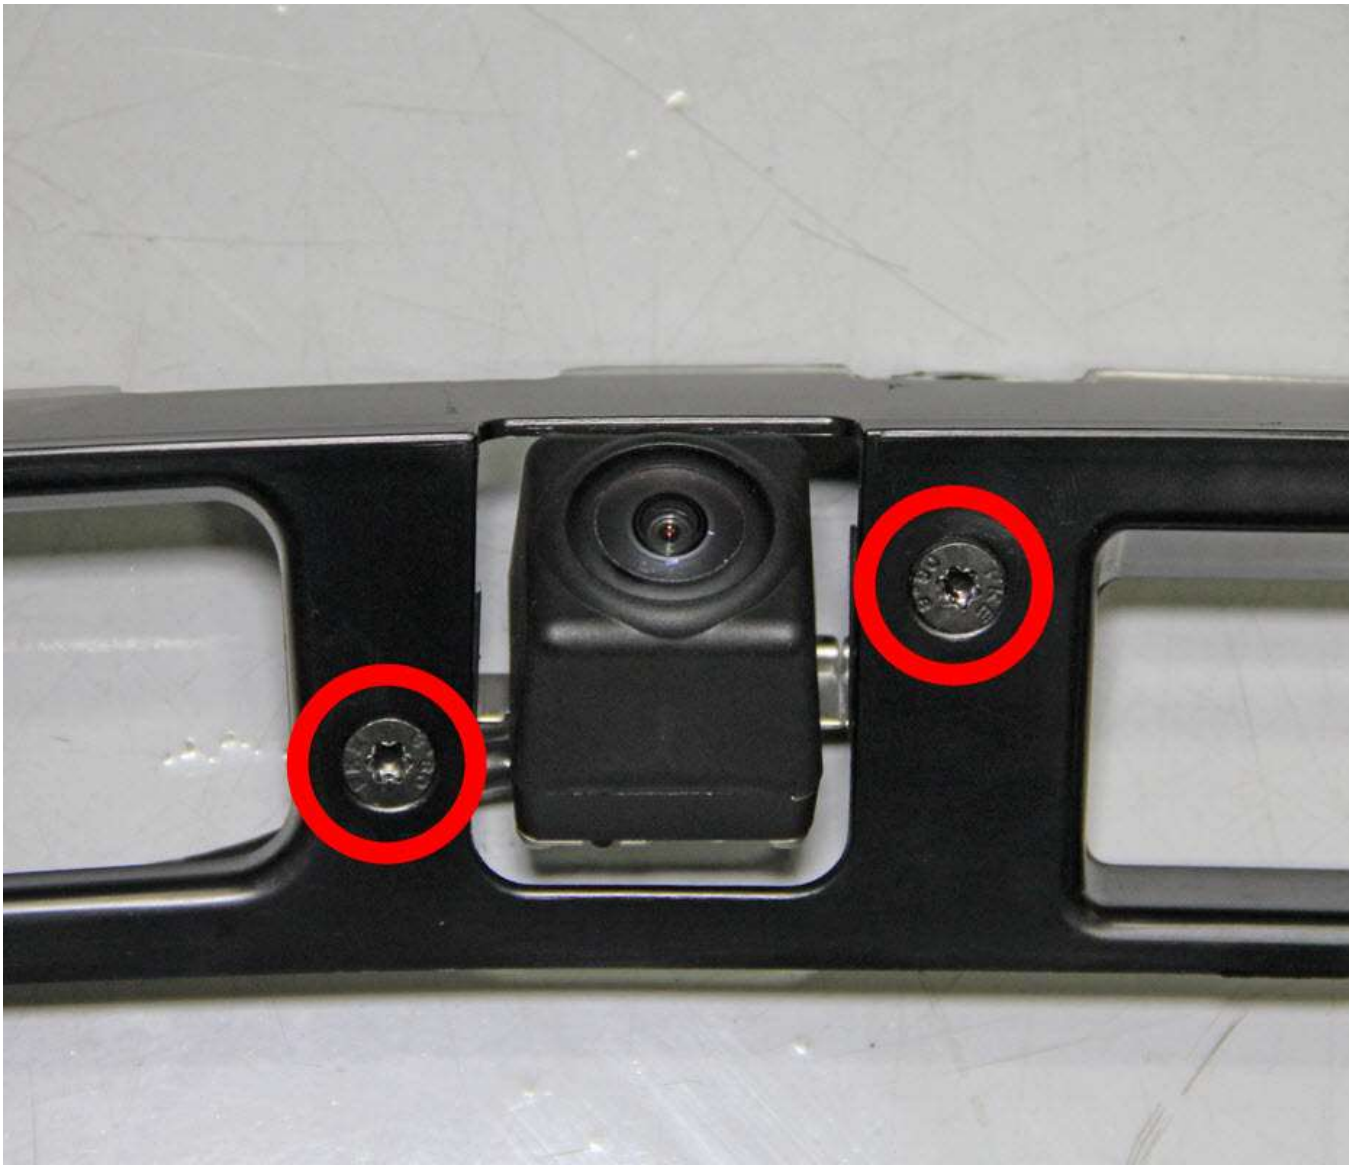
7. Release the screws (x2) that secure the camera to the liftgate applique bracket (torque 2.8 Nm)

Components have been removed in this graphic to aid clarity.
